Little Dome C

Beyond EPICA Oldest Ice Drilling Site (75.29917 °S, 122.44516 °E)

Situation Report #25; Tuesday 27 December 2022

One small screw – lost and found

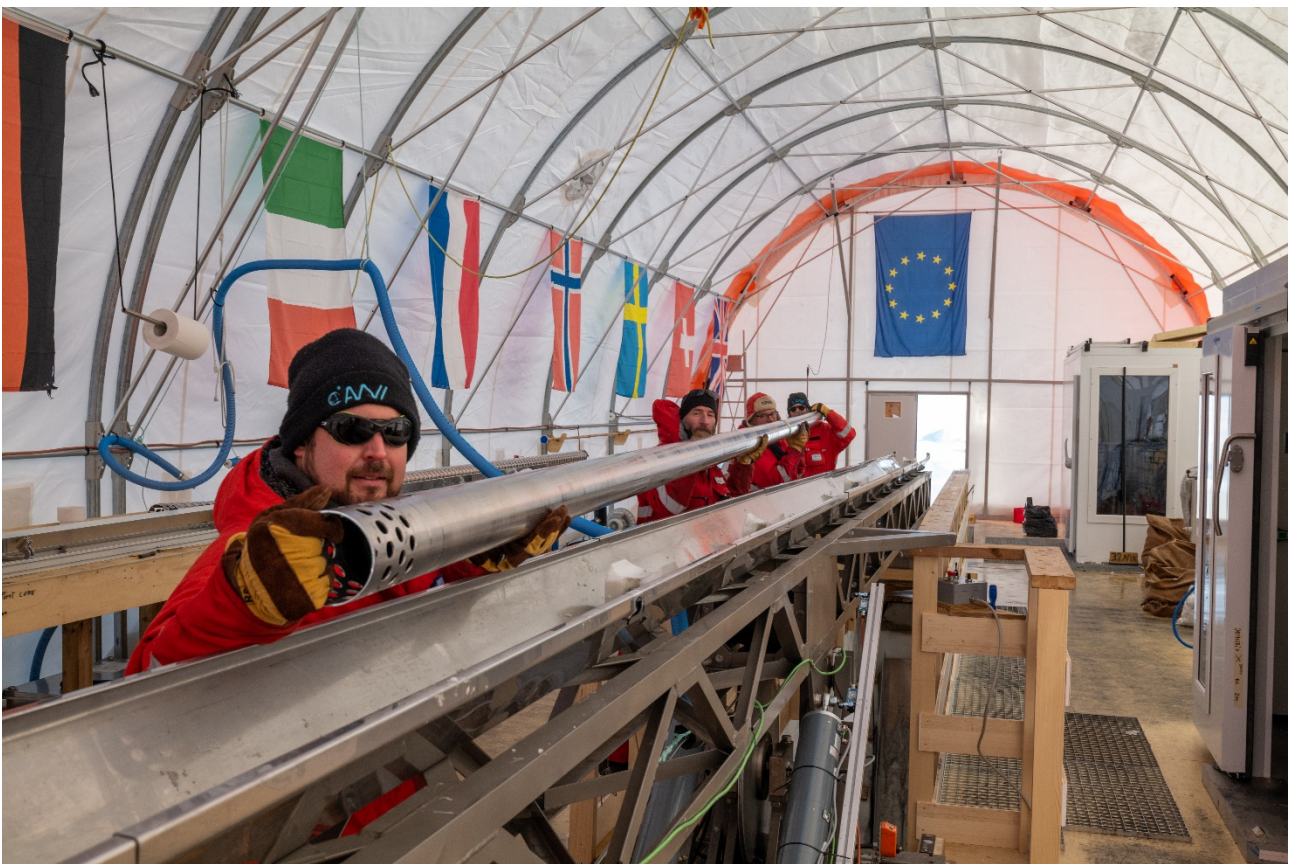
Photo held over from previous day.... The 4-meter system outer barrel, which is 10 m long, is brought into the drill tent by (left to right) Matthias, Lemmi, Frank and Gunther to mount onto the drill tower, and connect to the anti-torque and motor sections. (Photo: Mulvaney, Leica SL2, 35mm, 1/160, f10, ISO400)

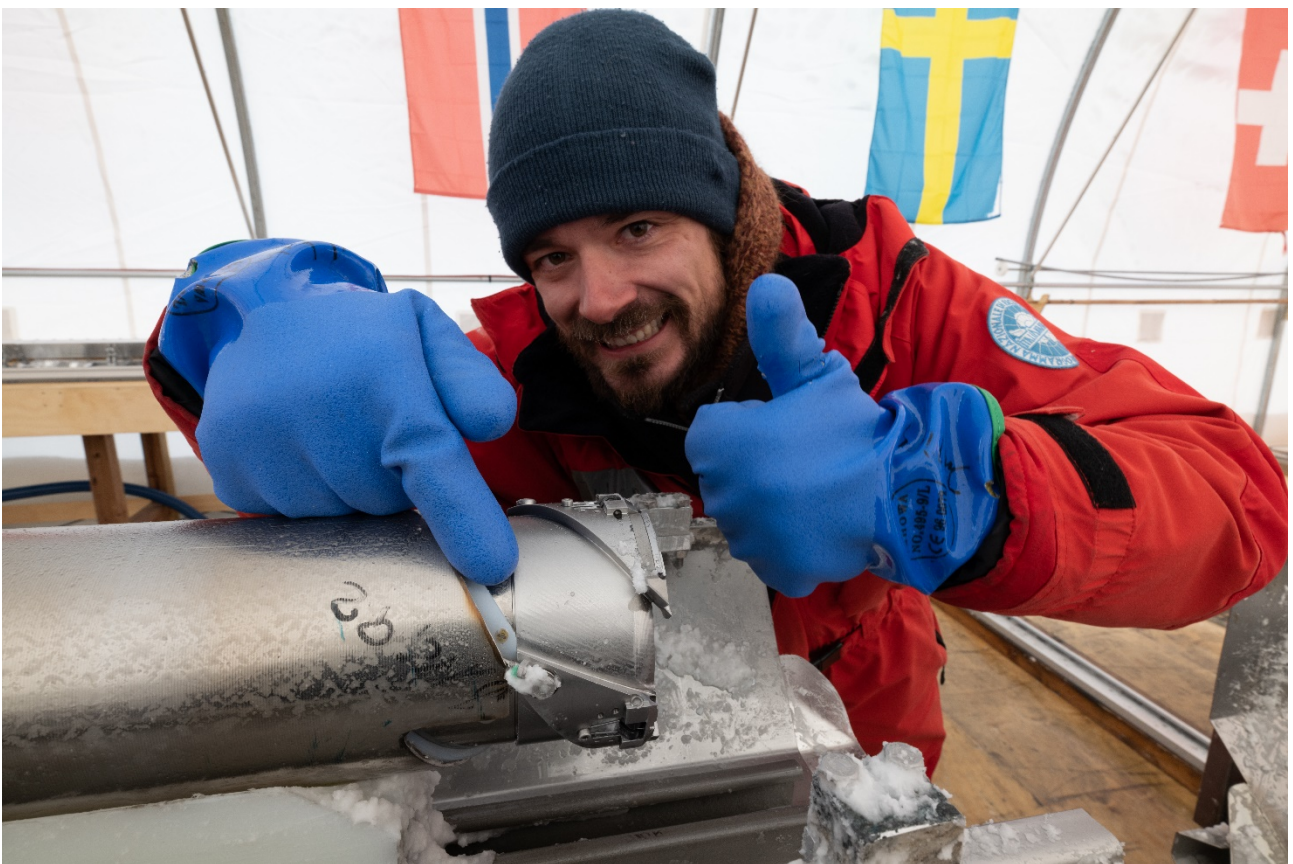
Julien shows of the lost and finally recovered screw. (Photo: Mulvaney, Leica SL2, 20mm, 1/25, f11, ISO400)

After the change to the 4-meter core barrel drill yesterday evening, and with three good runs, we continued with the longer core system this morning. After two runs of over three meters, we had some bad luck: one of the three spring-loaded pins that lock the hollow shaft onto the drive shaft of the motor popped out when re-mounting the hollow shaft. Further inspection revealed that the screw that held the locking pin in the mount had been lost. The suspicion was that the screw had been lost during the previous run, and fallen into

the borehole, or with some luck had managed to be caught in the chip chamber. We spent a messy thirty minutes trawling through the chippings/fluid slurry from the last run (which comes out of the drill at a temperature of about -50°C) trying to locate the pin, but couldn't find it.

Hoping that we had simply missed the screw somewhere, we continued to drill, but the next few runs ended short, and with a high current, suggesting that the lost screw was down the hole, and interfering with the cutting of ice by the drill head. Surprisingly, we saw no damage to the cutters which is normal in this situation, and meant that we were not really certain that the screw was the cause of the short runs and high closing current.

However, during the last shift of the day, the run ended after only 14 cm of penetration with a sudden surge to a high current, and the drill motor stalling. Bringing the drill back to the surface revealed the lost screw jammed between the inner and outer barrel. No damage done, we will continue drilling.

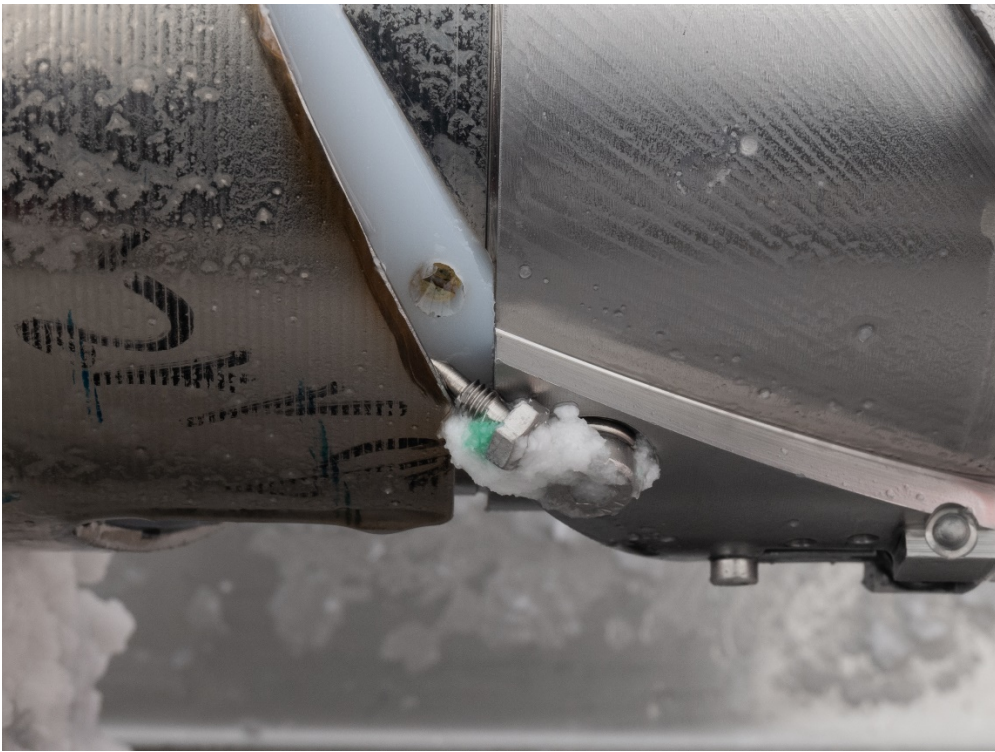
Close-up of the lost screw from the locking pin, jammed between the inner and outer barrel. (Photo: Mulvaney, Leica SL2, 35mm, 1/25, f11, ISO400)
