Little Dome C

Beyond EPICA Oldest Ice Drilling Site (75.29917 °S, 122.44516 °E)

Situation Report #26; Wednesday 28 December 2022

The day the hatch broke, and disappointing drilling

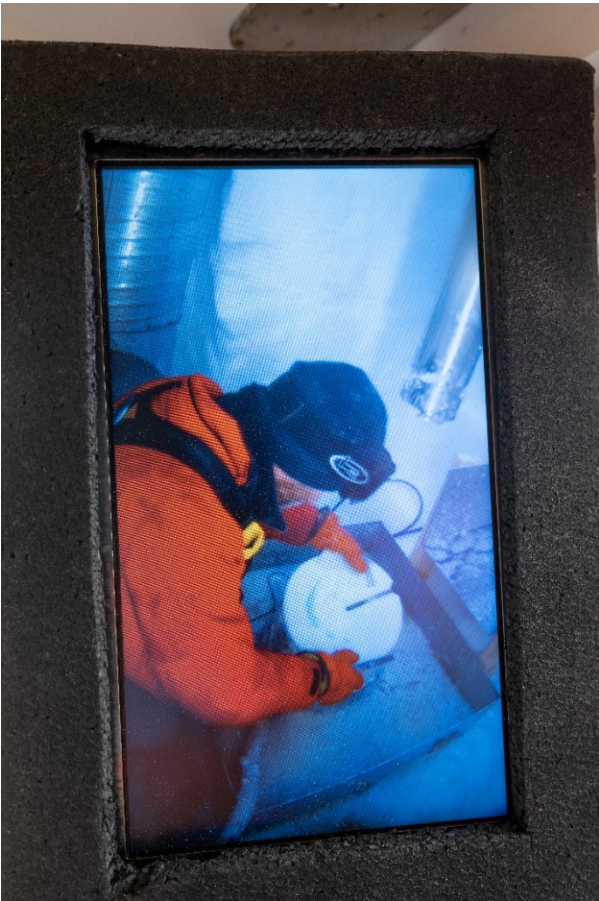
Martin at the bottom of the inclined trench, replacing the broken hatch on the borehole well-head. The photo is taken of the image on a video display in the drillers cabin that takes a video feed from a camera trained on the well-head. We normally use this display to monitor the safe entry of the drill into the borehole. Above Martin's head hangs the drill, while to his left is a ventilation shaft that sucks away the drilling fluid fumes that otherwise accumulate at the bottom of the trench.

Martin had the task of working at the bottom of the inclined trench for about an hour to replace the hatch. One further thing to note: the temperature at the bottom on the trench is about -35°C – not a comfortable place to work.

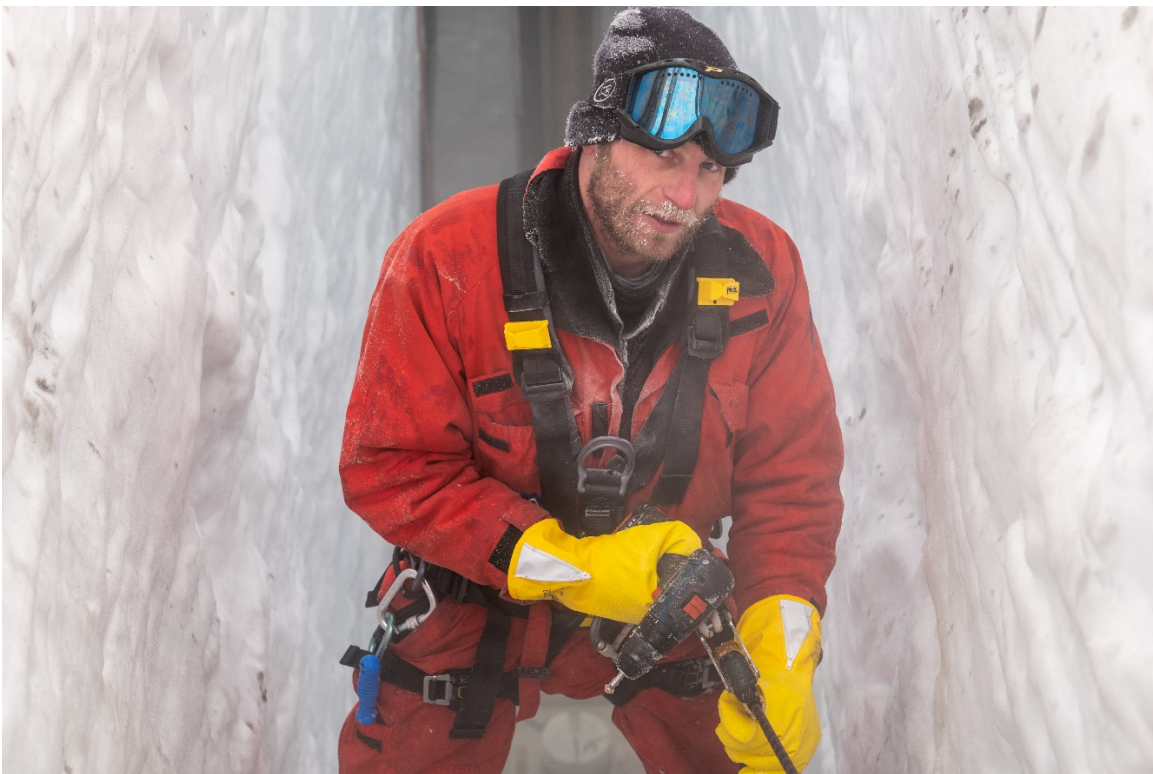
Martin emerges from the inclined trench, tools in hand, after repairing the broken well-head hatch with a new piece of polyethylene that should cope with the temperature at the bottom of the trench. (Photo: Mulvaney, Leica SL2-S, 70mm, 1/125, f7, ISO400)
